MARINER NEWS

BAYTRONICS
CORPORATION

SUBJECT: Mariner 1500 Instruction and Service Manual
Chassis Wiring Diagram, Fig. 15

DATE: September 15, 1976

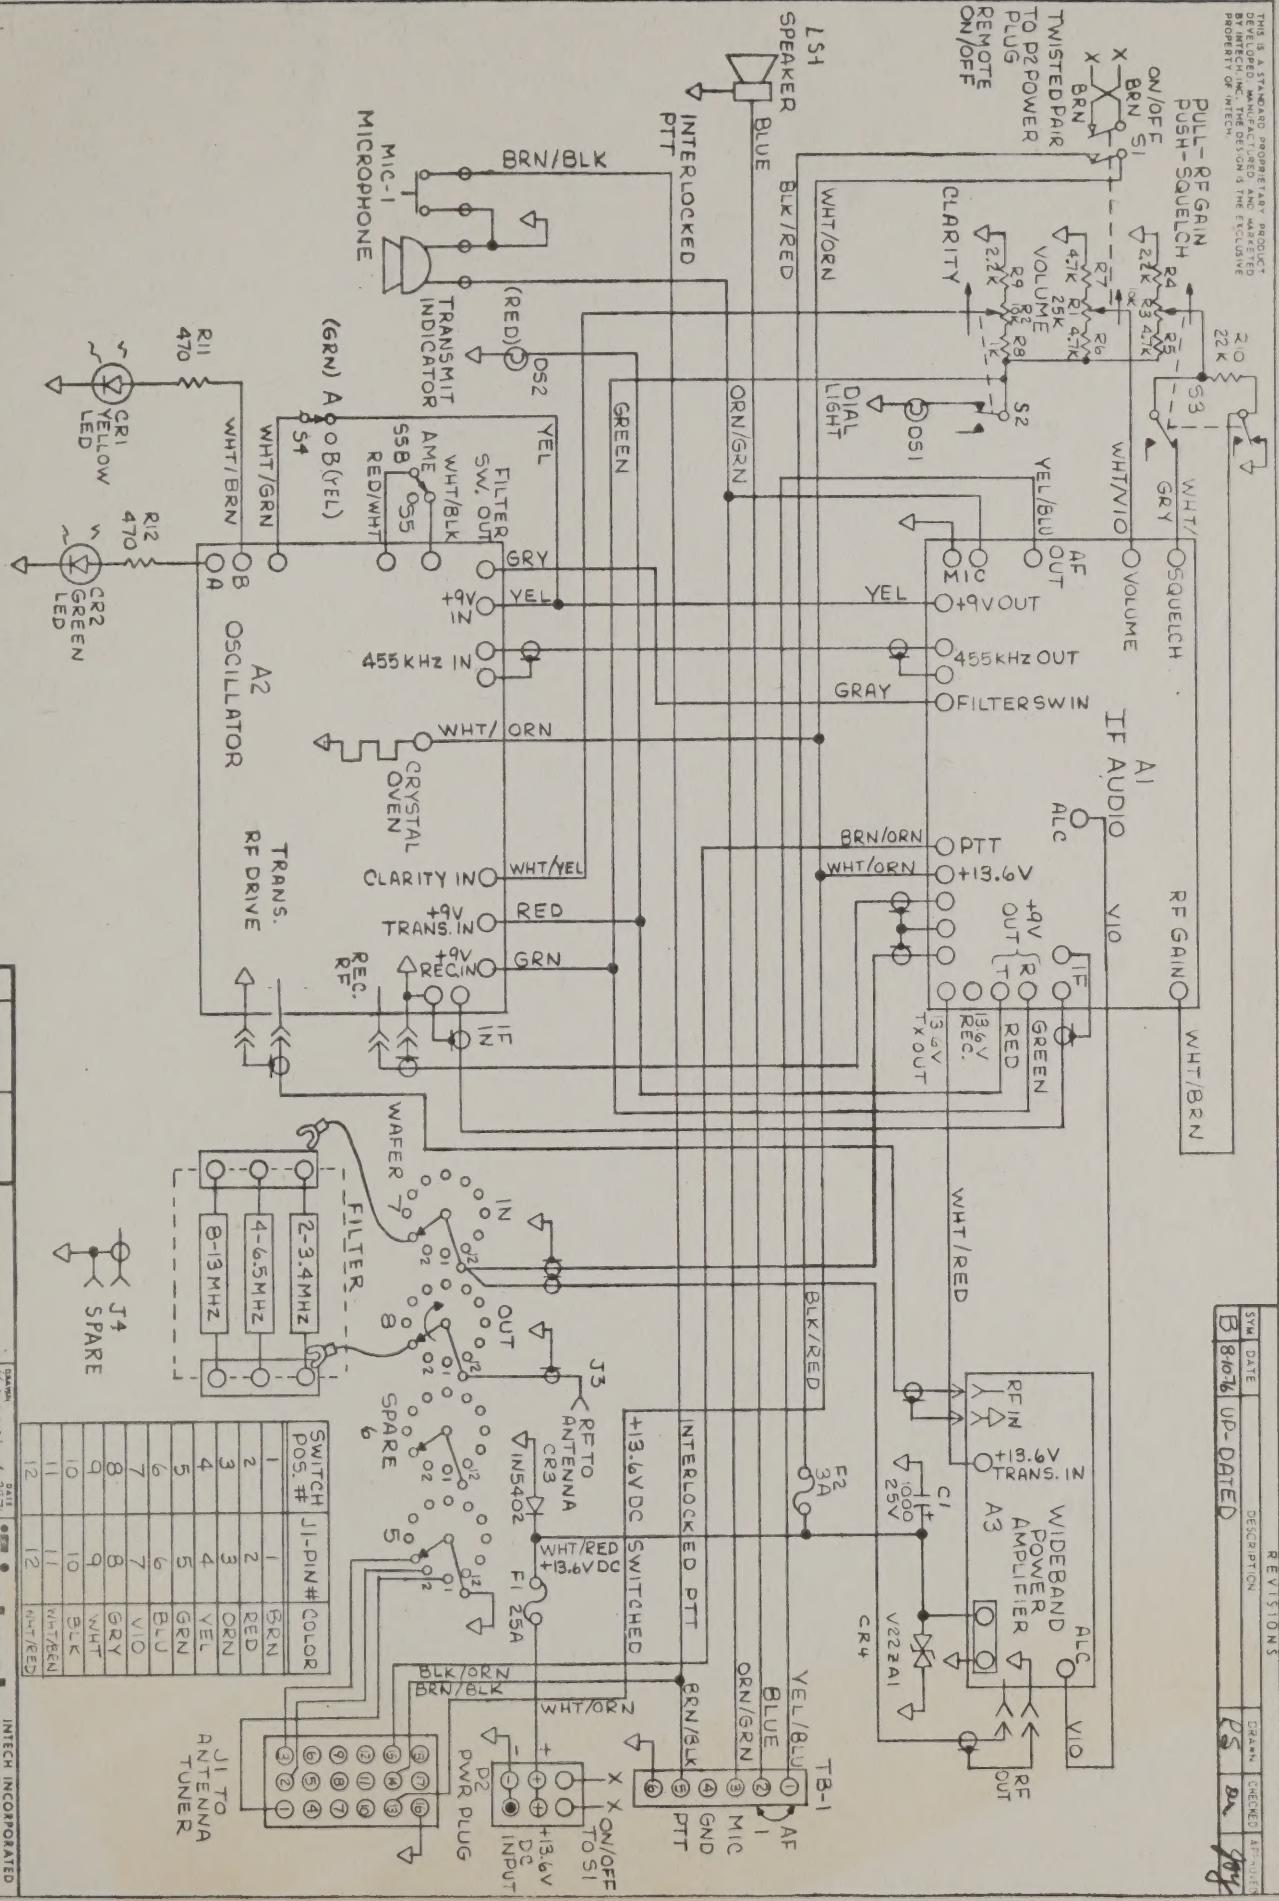
Fig. 15

The chassis wiring diagram (5-157041) represents graphically how wires and coaxial cables are connected to the circuit boards. Inadvertently, we crossed two coaxial cables leading from the low pass filter and Receiver RF (A2 board) to the IF Audio Board (A1). Note that the wiring diagram is error, not the actual wiring in the set. Enclosed are two copies of the corrected, revision B, wiring diagram. Please update service manuals as soon as possible.
